**Relates to:** Nissan Patrol

# Vehicle Specific Clutch Kit Installation Notes

# TBC13

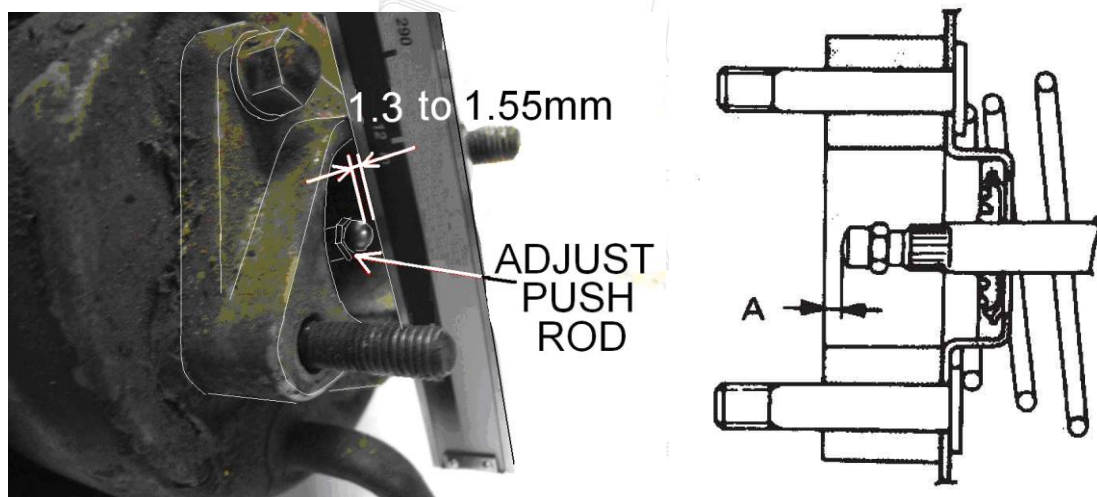
Fig 1.

A worn vacuum booster diaphragm can be the cause of faulty booster operation. Investigate the condition of the diaphragm and replace (suggested replacement - Nissan part # 30684-01J25 found in Nissan parts section 470) if required.

1. The booster is adjustable at the output rod of the booster (Ref Fig #1) and between the booster and the Master Cylinder (Ref Fig #2). After the booster is rebuilt, ensure that the adjustment of the push rod into the master cylinder is correct. Correct adjustment should be 1.30 – 1.55mm below the surface of the alloy mounting adaptor. If a non genuine master cylinder is used, back off the push rod and place bearing blue on the pushrod end, bolt up the
