# Clutch Kit Installation Notes

## Misalignment

TBC92

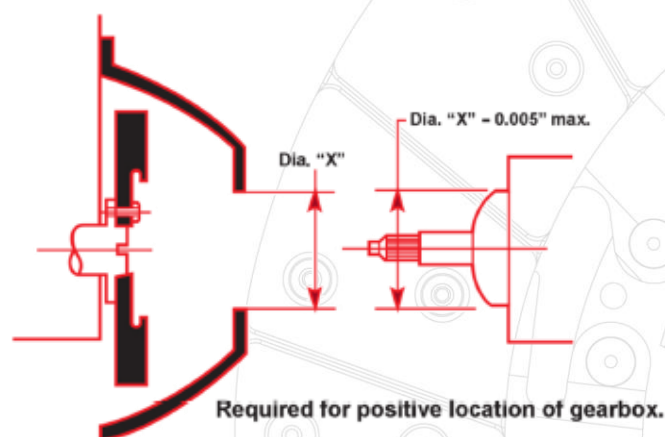
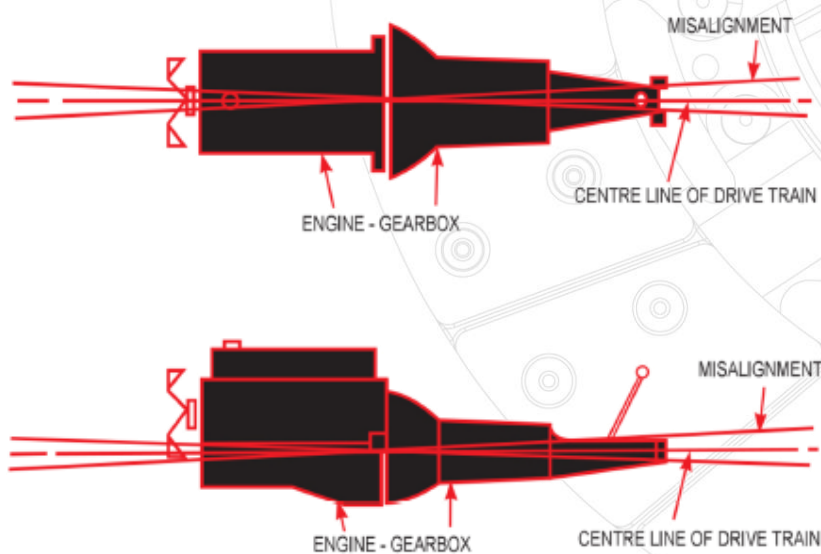
### DOES THE CLUTCH YOU HAVE JUST REMOVED SHOW ANY OF THESE SIGNS OF WEAR?

- > Broken clutch plate.
- > Worn diaphragm fingers.
- > Red dust covering the clutch assembly.
- > Loose pivot rings inside the cover assembly.
- > Release bearing guide worn on one side.

If it does, the clutch has probably failed due to driveline misalignment. Fitting a new clutch without rectifying any misalignment will lead to possible premature failure of the new clutch.
